Errata for FM25256 & FM25L256

Errata Number 003 (all Date Codes)
Date May 3, 2005
Product Marking FM25256 and FM25L256 (all package types)

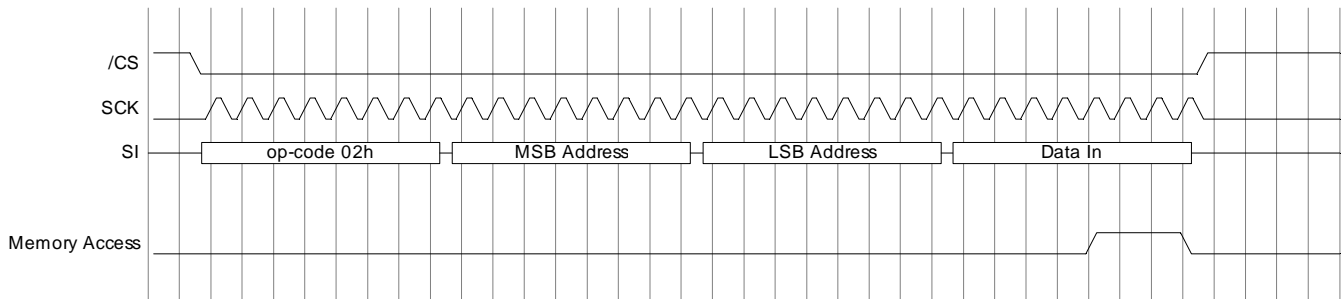
Figure 1. Write Operation Starts on 5th Clock and Completes on 8th Clock

The following describes the internal operation of the 256Kbit SPI FRAM memories. These parts are designed to support serial data rates in excess of 20 MHz, however there is a limitation at very low speeds. The SPI operations are byte oriented and are initiated on the falling edge of /CS. The following diagram shows a write operation and includes the internal signal "Memory Access" to show when the memory array is accessed. For each data byte the array is accessed on the 5th clock and is closed on the 8th clock.

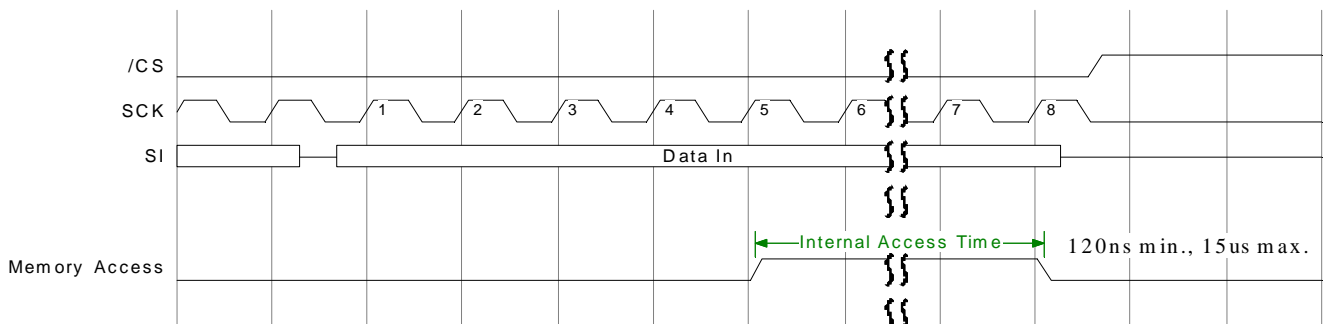
Figure 2. A Detailed Look at the Internal Memory Access and Timing Constraint

For write operations the length of time the array is being accessed is a function of clock frequency, a temporarily stopped clock, and the time /HOLD is asserted. Testing has identified an errata condition for the FM25256 and FM25L256 devices. Current product versions have a timing constraint that the user must comply with – it is labeled "Internal Access Time" in the diagram below. The minimum time is 120ns (3 clocks at 25MHz) and the maximum time is 15 μ s. The maximum time of 15 μ s is exceeded if the clock frequency is lower than 200KHz, assuming a free-running clock and the /HOLD pin is not used within the memory access period.

NOTE: The above issue will be resolved with the next die revision. Samples will be available in 3Q05.
