Errata for FM20L08

Errata Number	002 (Rev AD)
Date	Jan. 24, 2005
Product	1Mbit FRAM, 128Kx8
Product Marking	FM20L08-60 (all package types)

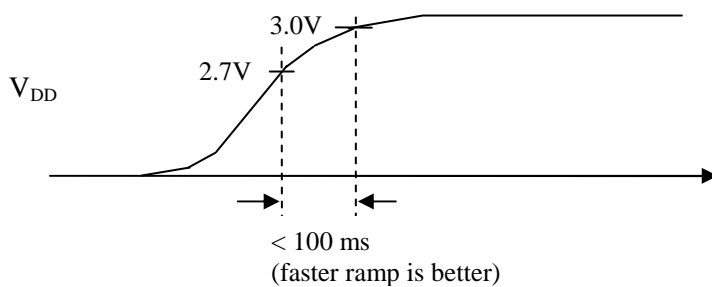
- 1) If the V_{DD} power-up ramp is too slow, the chip will lock out the user. V_{DD} must transition faster than 100 ms from 2.7V to 3.0V. See diagram below.

NOTE: The above issues will be addressed with a future device revision.

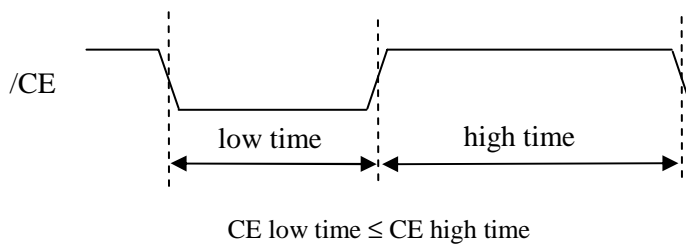
- 2) $/CE$ restrictions: $/CE$ low time $\leq 10 \mu s$ and $/CE$ low time \leq /CE high time.
