# Errata for FM20L08

<b>Errata Number</b>	003a (applies to Date Codes 0521 through 0605)
<b>Date</b>	Feb. 15, 2006
<b>Product</b>	1Mbit FRAM, 128Kx8
<b>Product Marking</b>	FM20L08-60-TGC (commercial temperature)

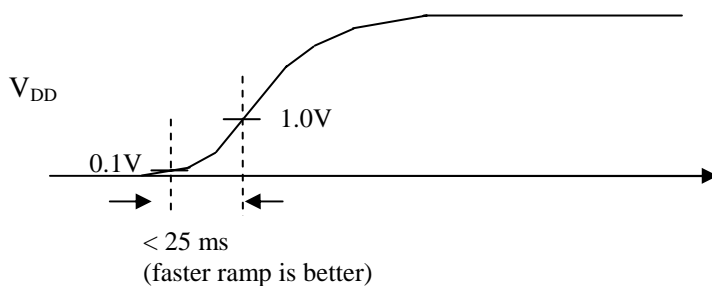
- 1) If the  $V_{DD}$  power-up ramp is too slow, the chip will not function properly.  $V_{DD}$  must transition faster than 25 ms from 0.1V to 1.0V. See diagram below.

NOTE: The above issues have been addressed with a new die revision, which are now available as engineering samples. These are marked D/C 0606 and beyond.
