Errata for FM20L08

Errata Number	003c (applies to Date Codes up to 0605)
Date	Feb. 15, 2006
Product	1Mbit FRAM, 128Kx8
Product Marking	FM20L08-60-TG (extended temperature)

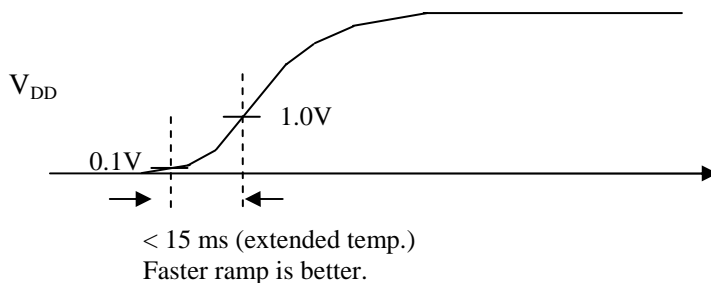
- 1) If the V_{DD} power-up ramp is too slow, the chip will not function properly. V_{DD} must transition faster than 15 ms from 0.1V to 1.0V. See diagram below.

NOTE: The above issues have been addressed with a new die revision, which are now available as engineering samples. These are marked D/C 0606 and beyond.
